PUNTLAND INFORMATION MANAGEMENT CENTER
FOR WATER & LAND RESOURCES (IMC)

KARKAR & NUGAL-GIBIN WATERSHED STUDY REPORT

2024

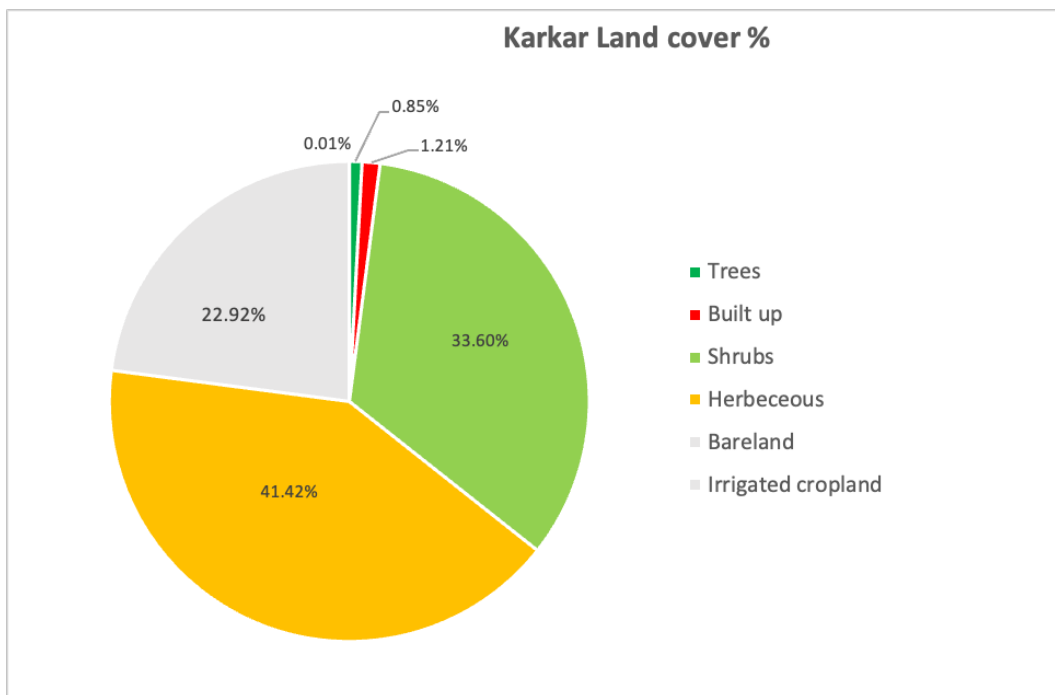
Figure 1: Karkar Land cover in percentage

This pie chart displays the percentage distribution of various land cover types in the Karkar Watershed. The dominant land cover is Herbaceous, which accounts for 41.42%, Shrubs are the second most common occupying 33.60% of the land. Bareland, indicated comprises 22.92% of the area, Built-up area make up 1.21%, while the least represented covers are Irrigated Cropland at 0.85% and Trees at 0.01%.

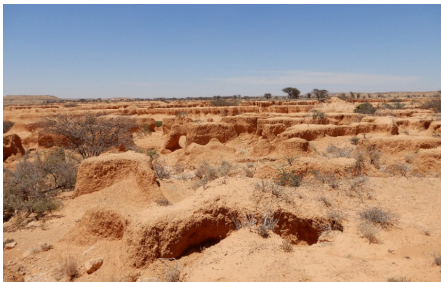
Degradation type	Selected hotspot gully Images	Main drivers identified	Proposed and Recommended Interventions
<p>Degradation type: gully erosion</p> <p>Location: Hodobohol</p> <p>Coordinates: 9.619217056, 49.31371458</p> <p>Site: 19</p>

<p><i>Figure 2: Hodobohol Gully</i></p>	<p>Reduced vegetation cover as result of unsustainable land practices, combined with the steep sloping and elevated terrain resulting in the initiation and enlargement of this gully in Hodobohol</p>	<p>Comprehensive initiatives of sustainable soil and water conservation strategy is recommended.</p> <p>Implementation of proper Gabions rather than stone/rock piles, afforestation of degraded land is pivotal to restore the land resources.</p>
<p>Degradation type: gully erosion</p> <p>Location: Gelis iyo Cudud</p> <p>Coordinates: 9.435646305, 49.15544301</p> <p>Site: 21</p>

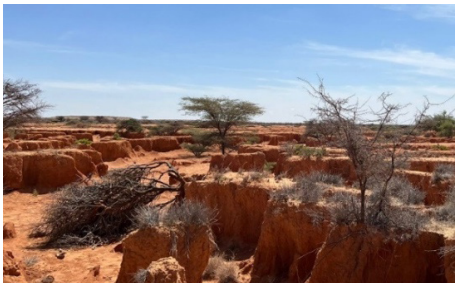
<p><i>Figure 3: Gelis & Cudud Gully</i></p>	<p>This area lies high elevation associated with steep sloping and the soil's limited capacity for rapid absorption, generate surface runoff that catalyzes the gully erosion process through removal of topsoil.</p> <p>The loss in vegetation cover because of overgrazing, tree cutting.</p>	<p>Implementation of sustainable Water and soil conservation structure, sustainable grassing practices of (seasonal grazing and proper livestock herd size management), Afforestation of endogenous tree and herbaceous species is recommended including <i>Andropogon kelleri</i> to reduce runoffs and restore ecosystem.</p>

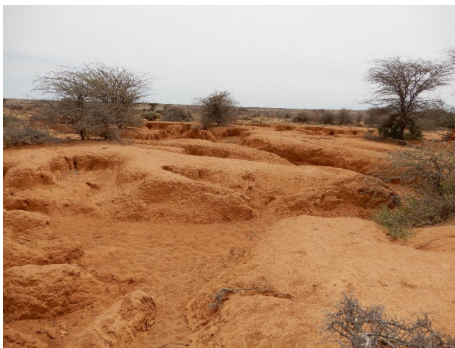
<p>Degradation type: gully erosion</p> <p>Location: Baqafuul</p> <p>Coordinates: 9.908295, 49.238099</p> <p>Site: 11</p>

<p><i>Figure 3: Baqafuul Gully</i></p>	<p>Poor soil quality associated with limited capacity to absorb high rainfall amounts and moderate sloping and increased elevation of the sites caused gully erosion of the site.</p> <p>Additionally, un sustainable land use system of overgrazing is also prominent in the area.</p>	<p>Soil quality improvement through sustainable soil and water conservation structures, such as gabions and afforestation is important.</p> <p>To address the issue of overgrazing rotational grassing practices is suggested.</p>

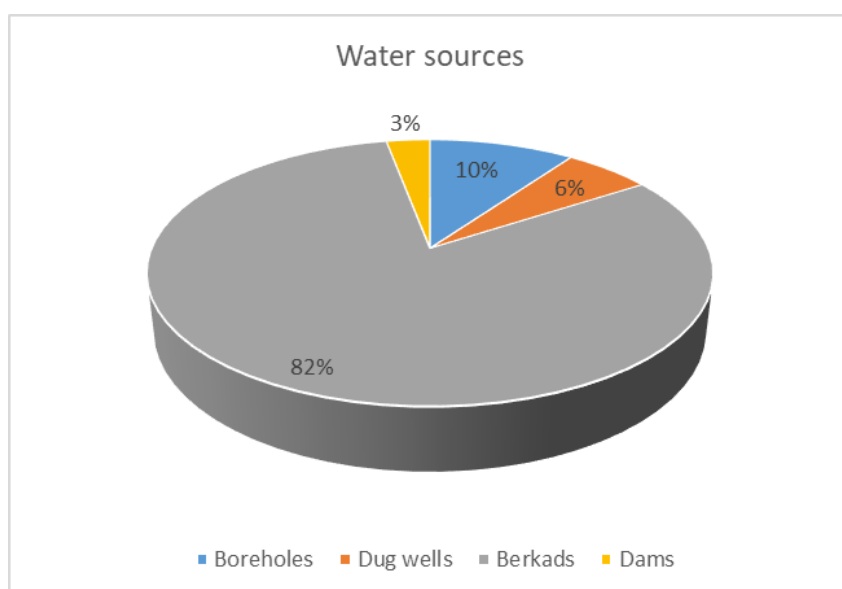
Figure 5: Water sources of Karkar Watershed

82% of the consumption of Karkar watershed depends on surface water such as Berkeds, which shows the significance contribution of the surface water in the livelihoods of the communities. While 10% of the consumption depends on groundwater such as boreholes.

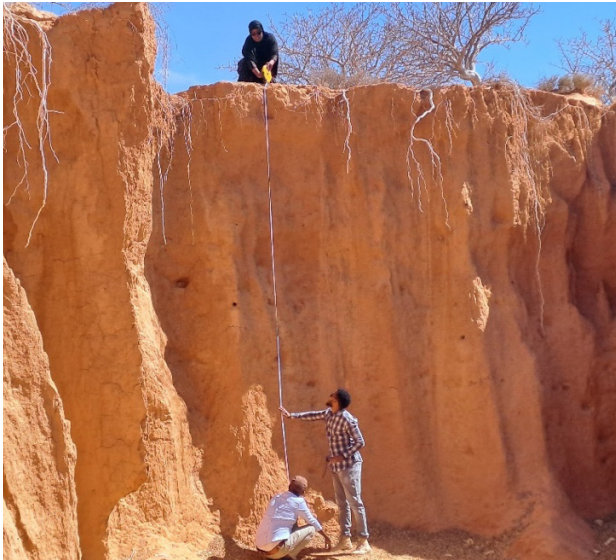
Degradation type	Selected hotspot gully Images	Main drivers identified	Proposed Interventions
<p>Degradation type: gully erosion</p> <p>Location: Wamaaley</p> <p>Coordinates: 8.69170376 ,49.30329467</p> <p>Site: 7</p>

<p><i>Figure 7: Wamaaley Gully</i></p>	<p>The main drivers of this gully erosion are loss of vegetation cover (deforestation and overgrazing), weak soil structure, steep slope, high elevation and high intensity of rainfall, and frequent droughts.</p>	<p>Afforestation and reforestation of degraded sites associated with sustainable soil and water conservation techniques are advised.</p> <p>Stone/rock pile Interventions seems in effective for gully erosion control so sustainable way for ecosystem restoration is necessary through comprehensive study for suitable soil conservation in the sub watershed.</p> <p>Construction of Gabions, Proper water and harvesting techniques could play a significant role in reducing water runoffs.</p>

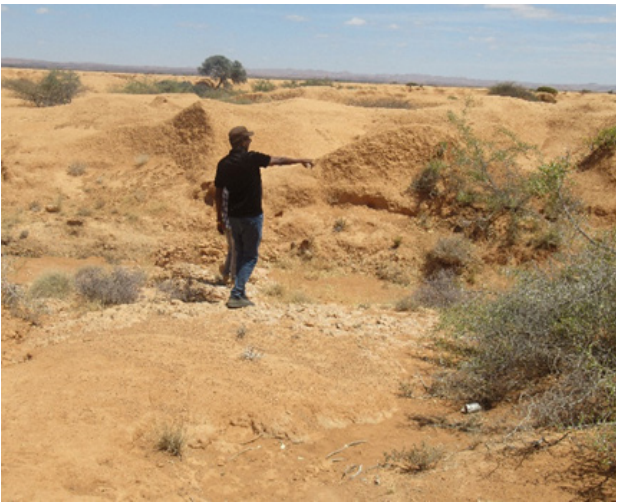
<p>Degradation type: gully erosion</p> <p>Location: Salaama</p> <p>Coordinates: 8.59216316,49.10116893</p> <p>Site: 2</p>

<p><i>Figure 8: Salaama Gully</i></p>	<p>This area lies high elevation associated with steep sloping and the soil's limited capacity for rapid absorption, generates surface runoff that catalyzes the gully erosion process through removal of topsoil.</p> <p>The loss in vegetation cover as a result of overgrazing is also another main driver for this gully expansion.</p>	<p>Soil conservation and restoration of degraded gully sites to reduce topsoil loss is indispensable.</p> <p>Sustainable land use practices are recommended to reduce overgrazing and deforestation from human activities.</p>
<p>Degradation type: gully erosion</p> <p>Location: Durdurista</p> <p>Coordinates: 8.798695, 49.23543</p> <p>Site: 24</p>

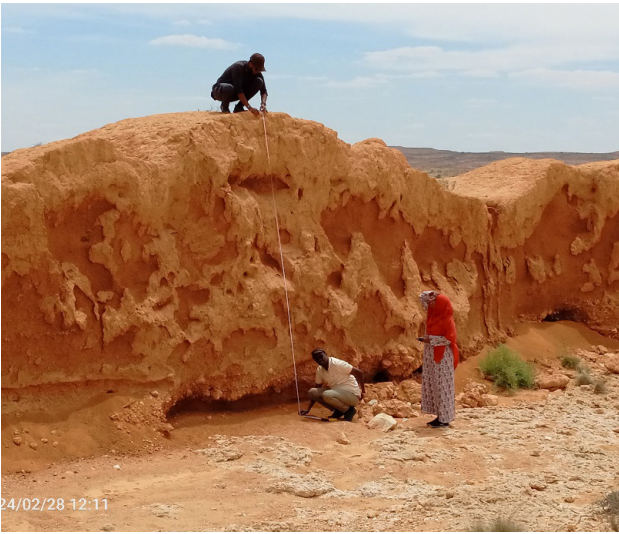
<p><i>Figure 9: Durdurista Gully</i></p>	<p>Poor soil quality associated with limited capacity to absorb high rainfall amounts and moderate sloping and increased elevation of the sites caused gully erosion of the site.</p> <p>Additionally, Un sustainable land use system of overgrazing is also prominent in the area.</p>	<p>To prevent the loss of topsoil, soil conservation and restoration of degraded gully sites are essential.</p> <p>It is advised to utilize sustainable land use techniques to lessen overgrazing and human-caused deforestation.</p>

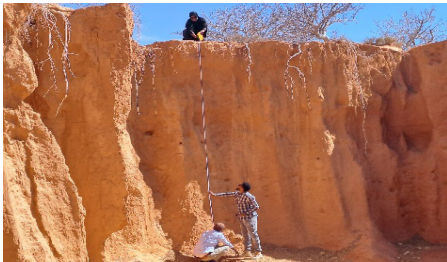
Gully erosion
